## WEATHERING PROCESSES AND THEIR EFFECTS ON STONE-BUILT CULTURAL HERITAGE. CASE STUDY: "SAINT ARCHANGELS" CHURCH, DEAG VILLAGE

#### 3.1. Case study: “Holy Archangels Michael and Gabriel Church”, Deag Village

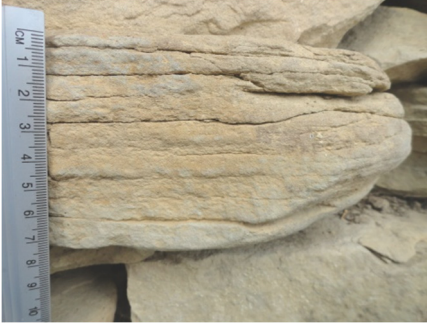
*Delamination* is predominant on the southern and northern parts of the foundation. The rocks with southern exposure are few in number but are severely affected (fig. 2). Some of the bedding planes completely detached and fell to the ground. The loss of lithic material has left a number of holes into the foundation (fig. 3). According to Torracca (2009), delamination is caused by the repeated action of freeze – thaw cycles (frost weathering). Aroldi (2005) attributes it to both frost weathering and termoclasty. The latter can be justified only in the case of the rocks that are situated on the southern side of the foundation which are exposed to direct solar radiation.

**Fig. 2.** Severe delamination along the bedding planes.

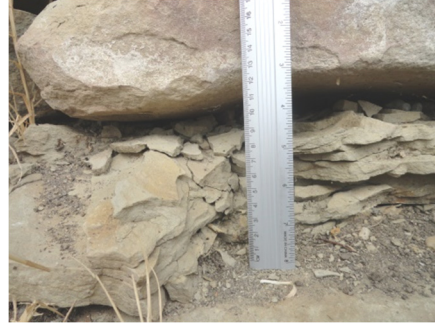
**Fig. 3.** Partial disintegration caused by severe delamination.

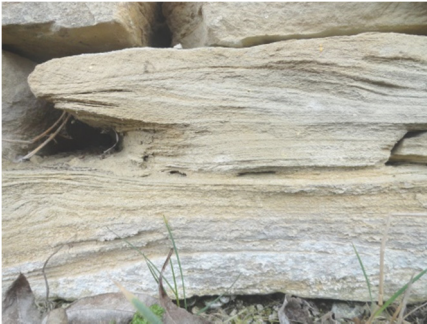
Some of the rocks located on the northern side of the foundation have been affected by both delamination and *granular disintegration*. The association of these two weathering forms has created a sculptural and sandy surface (fig. 4). White *efflorescence stains* have been noticed on a small number of rocks located at the lower part of the foundation. They are the result of the dissolution of the calcium carbonate and may indicate a more severe deterioration beneath the surface (fig. 5). Oxidation has affected a large number of rocks, on all sides of the foundation, causing chromatic modification but did not involve any visible surface deterioration.

**Fig. 4.** Delamination and granular disintegration.

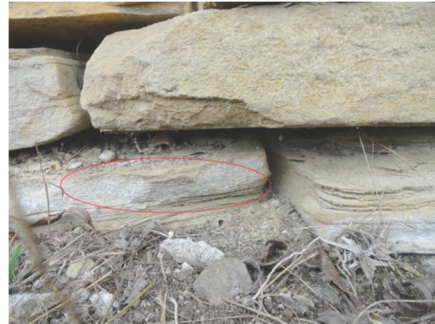
**Fig. 5.** White efflorescence caused by the dissolution of calcium carbonate.

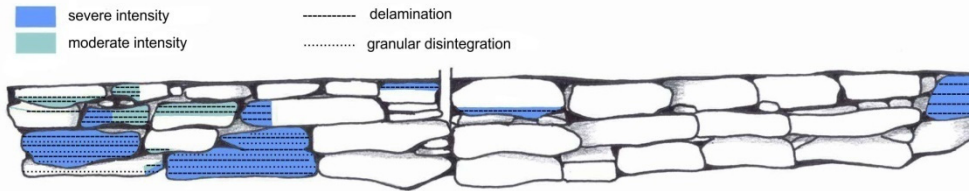
The *in situ* macroscopic investigation was finalised with the mapping of the weathering forms, a method intended for monitoring their evolution (fig. 6 and 7). The middle section of the northern side was chosen for this purpose because it includes all identified weathering forms.

**Fig. 6.** Physical weathering forms.

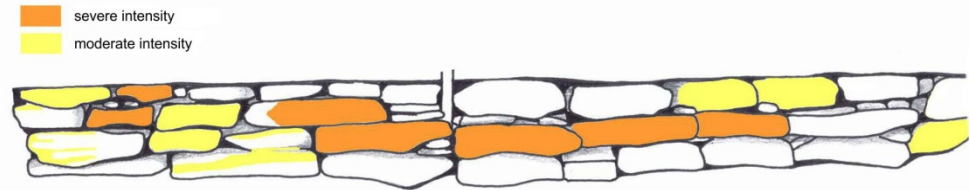
**Fig. 7.** Chromatic alteration caused oxidation.

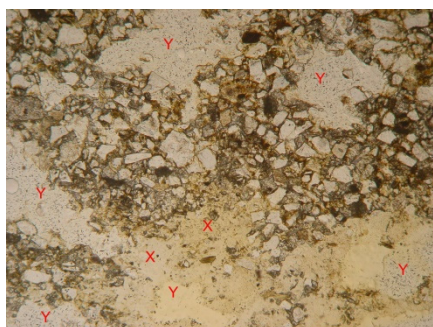
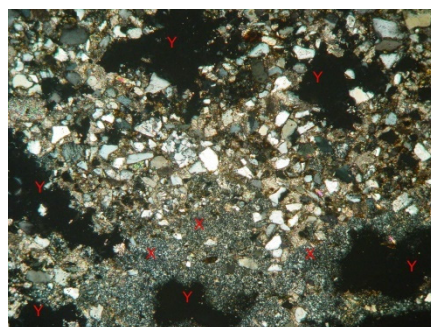
The microscope analysis of the samples has identified the presence of secondary gypsum crystals (*subefflorescence*) (fig. 10 and 11). The pressure exerted by the newly formed crystals is rather dangerous as it may cause structural damage by breaking down the walls of the pores. The *dissolution of calcium carbonate* has left empty spaces between the particles (dissolution pores), thus weakening the sandstone's mechanical resistance and facilitating further weathering (fig. 10 and 11). The lack of cement is one of the causes of granular disintegration. *Oxidation* was caused by both chemical and biological weathering. Microscope images show the presence of iron bacteria (fig. 12 and 13).

**Fig. 10.** Microscope analysis in plane - polarized light. **Fig. 11.** Microscope analysis in crossed - polarized light. Both photos show: X – gypsum crystals; Y – dissolution pores.

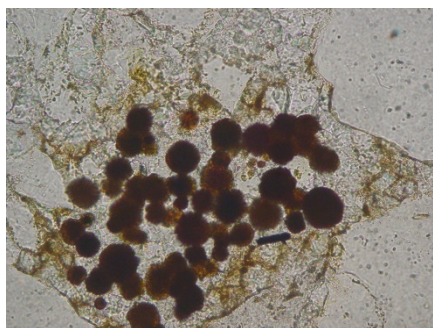
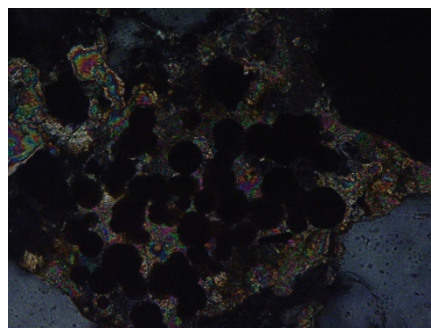
**Fig. 12.** Microscope analysis in plane - polarized light. **Fig. 13.** Microscope analysis in crossed - polarized light. Both photos show iron bacteria.
