IDENTIFYING LANDSLIDE HAZARD IN THE CHECHIȘ CATCHMENT, BAIA MARE DEPRESSION

ABSTRACT. – **Identifying Landslide Hazard in the Chechiș Catchment, Baia Mare Depression.** One of the starting points when assessing landslide risk is hazard identification, represented by the description of the landslide process and the extent to which it has an impact on the human community. Different areas affected by sliding processes have been identified and mapped on the field in the 100 km² of the Chechiș catchment, a territory situated to the south of Baia Mare municipality. Several other areas are considered to be susceptible to sliding processes, based on the factors which have influenced the occurrence of the ones already identified. Past and present effects of the existing landslides are illustrated and discussed together with the costs associated to the measures needed for their mitigation. In the view of these results, a landslide risk assessment is considered necessary in the area.

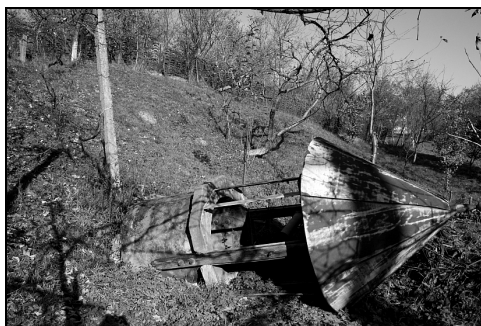
Fig. 4. Overturned fountain in Groşi area. Water table at 1 m from ground surface (2012).

Groşi area (fig. 2) has been previously studied (F.L. Măguţ et al., 2012) using large areas affected by landslide movements as the basis for mapping landslide susceptibility using logistic regression and the heuristic methodology from the Romanian legislation. At this point the landslide contours have been improved with further field observations and GPS mapping and profiling (fig. 3), as far as the weathering processes and the anthropic activities which transformed the landslides have allowed. Recent visible activity (fig. 4 and 5) confirms the 30-year recurrence interval (V. Surdeanu,

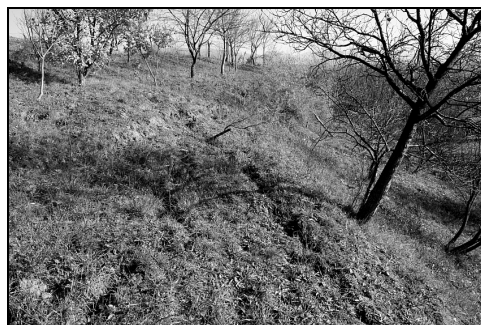
Fig. 5. Scarps marked in Fig.3. Left- northern scarp on the profile with fresh cracks, right – southern scarp with tilted vegetation (2012).

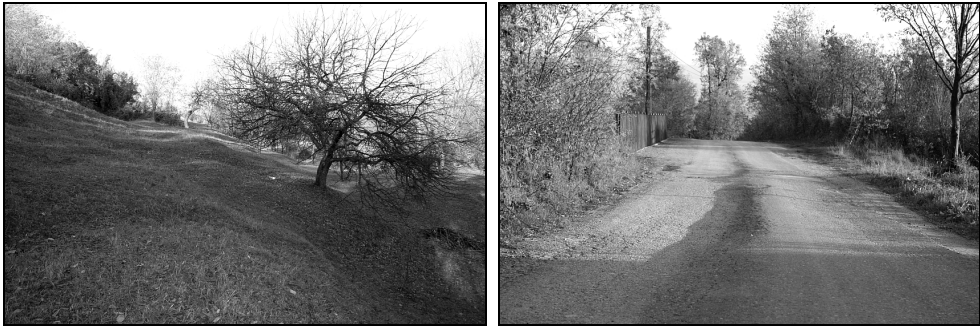
Fig. 6. Rotational landslide toe (left) illustrated in fig. 7, and damage to the road crossing landslide area on the southern Unguraș slope (right) (2012).

Similar conditions exist on the entire southern slope of the former piedmont unit bordering the Chechiş catchment in the north, including **Unguraş area** (fig. 2). The village with the same name is crossed by the local road linking Baia Mare and Baia Sprie with the inner parts of the catchment. Rotational landslides can be found on the whole length of the slope (fig. 6, left), the road crossing them transversally (fig. 6, right and fig.7) with only few stable segments.

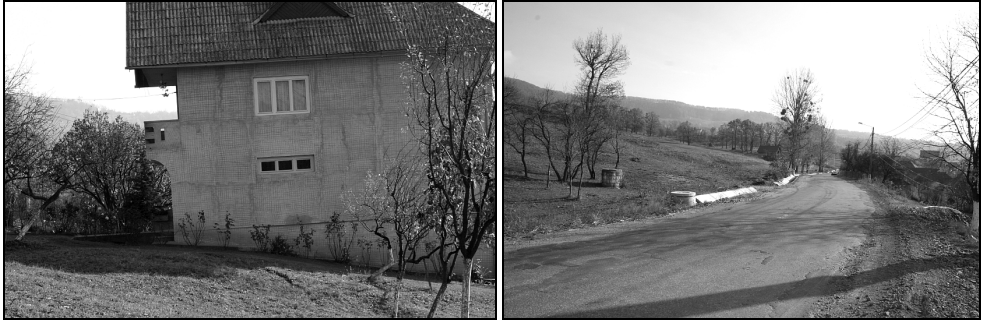
Fig. 8. Active failure near house indicated by cracks and tilted young trees (left) and the DJ 184 road in Baia Sprie - Șișești area (2012).

In **Baia Sprie - Șișești area** the Pannonian deposits influence the occurrence of landslides on the glaci of Mogoșa volcanic mountain (1245.9 m) with western and south-western slope aspect. As in the rest of the catchment, the 70s were marked by intense landslide activity leading to geotechnical measures necessary for the stabilisation of the DJ 184 road connecting Baia Sprie with Căvnic (fig. 8).

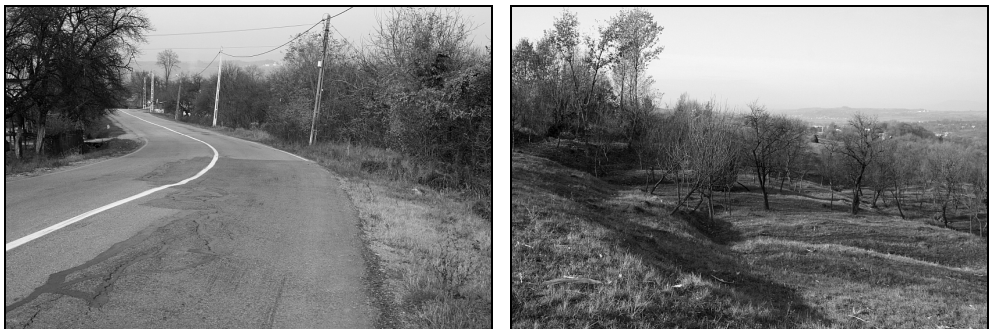
Fig. 10. The road DN 18B from Baia Mare to Tg. Lăpuș (left) and recent landslide movement indicated by tilted young trees in Cărbunari area (2012).

Constant damage to the road is what characterises **Cărbunari area** as well, where the DN 18B road was moved in the 50s due to a large landslide and was repeatedly affected in another sector afterwards. At present, cracks and deformations of the road indicate insufficient stabilisation measures in a landslide dynamic area, as just below the sector represented in fig. 10 the wall meant for its stability presents cracks in its turn. Situated at the lithological border between the Sarmatian and Pannonian deposits (fig. 2) the area is characterised by intense landslide activity determined by similar conditions as in the rest of the Chechiș catchment.

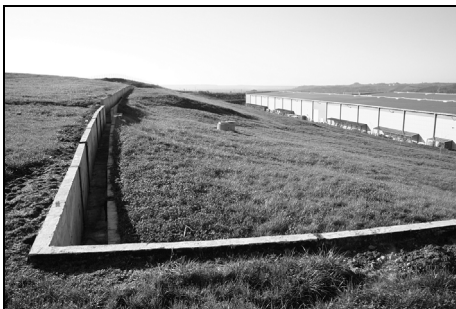
Fig. 15. Countermeasures above the factory building, Dumbrăvița (2012).

Due to the existence of a paleo drainage system at 12 m discovered through geoelectrical investigations (fig. 14), the danger of a deeper failure at -12 m was acknowledged and additional measures were taken in order to avoid its occurrence. These measures included: retaining walls, columns, drainage ditches, reduction of slope angle and stabilisation with geogrids and grass (fig. 15).
