HISTORICAL FLOOD OF 2005 IN TARCĂU CATCHMENT

ABSTRACT. – Historical Flood of 2005 in Tarcău Catchment. During the flood of 12 – 15 July the water level in the lower sector of the valley exceeded the one estimated for a 100-year flood, and the maximum discharge was almost twice larger than the previous peak. This extreme event generated the largest damage in Tarcău catchment, in total value of over 21,000,000 lei. The main affected element was the transport infrastructure. It also determined a change in flood perception of the local authorities, leading to the creation of a Voluntary Service for Emergency Situations the same year and investments in flood proofing.

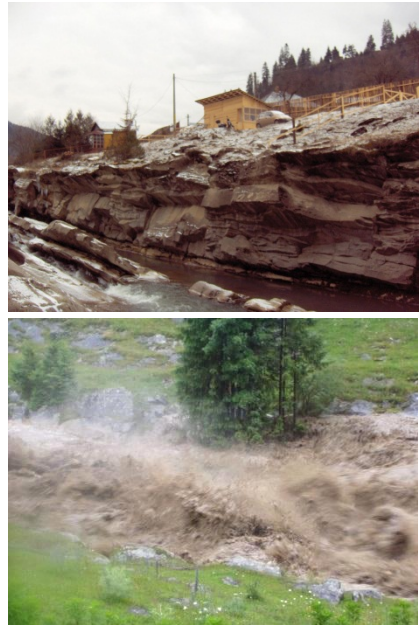
Fig. 2. The left bank of Tarcău River 25 m upstream of Cazaci gauging station (up); the water level during the historical flood in the same location (down—photo: Iulian Găină).

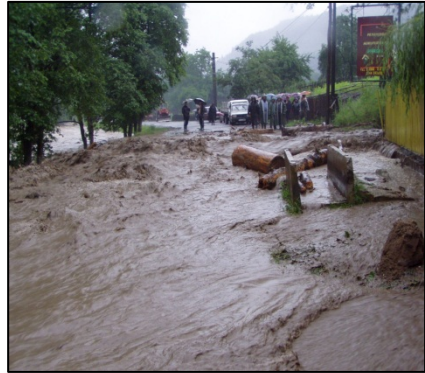
Fig. 6. The flooding of the Frasin and Tarcău junction (photo: Iulian Găină).

Downstream of Lunca Lăcătușului, at the junction of Frasin and Tarcău River, the culvert was destroyed by the flood on Frasin, the material brought by the tributary (fig. 6) including also wooden material. Considering the large percent of forest coverage, the main economic activity in the area is forest exploitation. On each major tributary valley there is a forest road that facilitates the access to the stands in exploitation. Abandonment of wood leftovers in the secondary valleys is frequent, and usually during floods this material is transported downstream, and its accumulation in narrow river bed sectors may create stoppers.
