## WEATHERING PROCESSES AND THEIR EFFECTS ON STONE-BUILT CULTURAL HERITAGE. CASE STUDY: "SAINT ARCHANGELS" CHURCH, DEAG VILLAGE

#### 3.1. Case study: “Holy Archangels Michael and Gabriel Church”, Deag Village

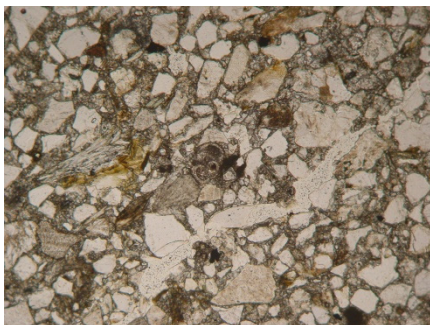
Thin sections of the samples were analysed using a Zeiss Axiolab Microscope. The following structural components were identified: mica, feldspar, quartz and bioclast fragments, cemented together with calcium carbonate (fig. 8 and 9).

**Fig. 8.** Microscope analysis in plane – polarized light. **Fig. 9.** Microscope analysis in crossed – polarized light. Both photos show: mica, quartz and bioclast fragments.
